DERAILMENT AND SUBSEQUENT BURNING
OF DELAWARE AND HUDSON
RAILWAY FREIGHT TRAIN AT
ONEONTA, NEW YORK
FEBRUARY 12, 1974

NATIONAL TRANSPORTATION SAFETY BOARD
Washington, D.C. 20591
REPORT NUMBER: NTSB-RAR-74-4

ADOPTED: OCTOBER 17, 1974

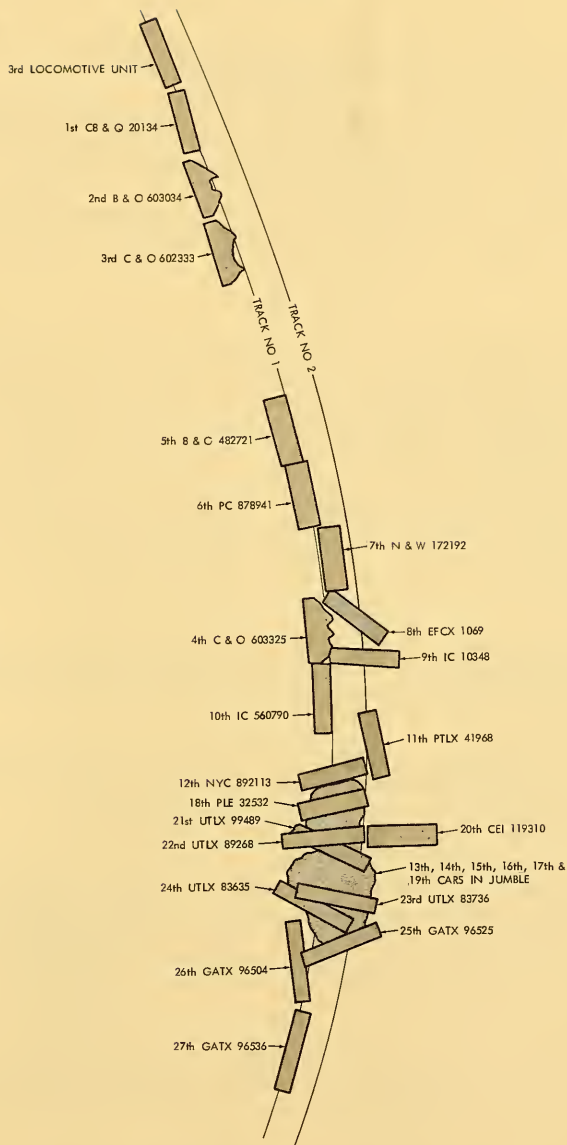
Cars 5, 6, and 7 passed Car 4 and stopped in various positions just north of Car 4. (See Figure 1.) Cars 1, 2, and 3 remained coupled to the locomotive, but overturned when they stopped.

Figure 1. Relative positions of derailed cars before explosions.

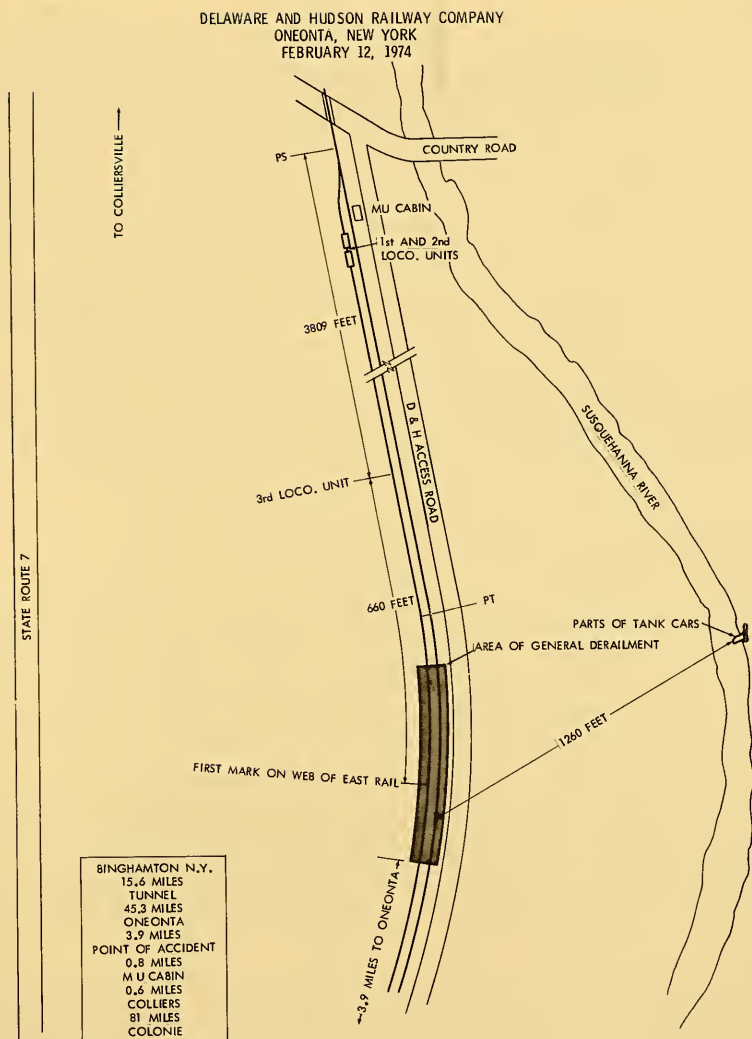
Figure 2. Area of the derailment.
